Beware the rolling effect

A near miss was recently reported on DYNAMARINE's OSIS online STS.net service regarding a ship-to-ship (STS) cargo transfer operation off Southwold on the UK's East Coast.

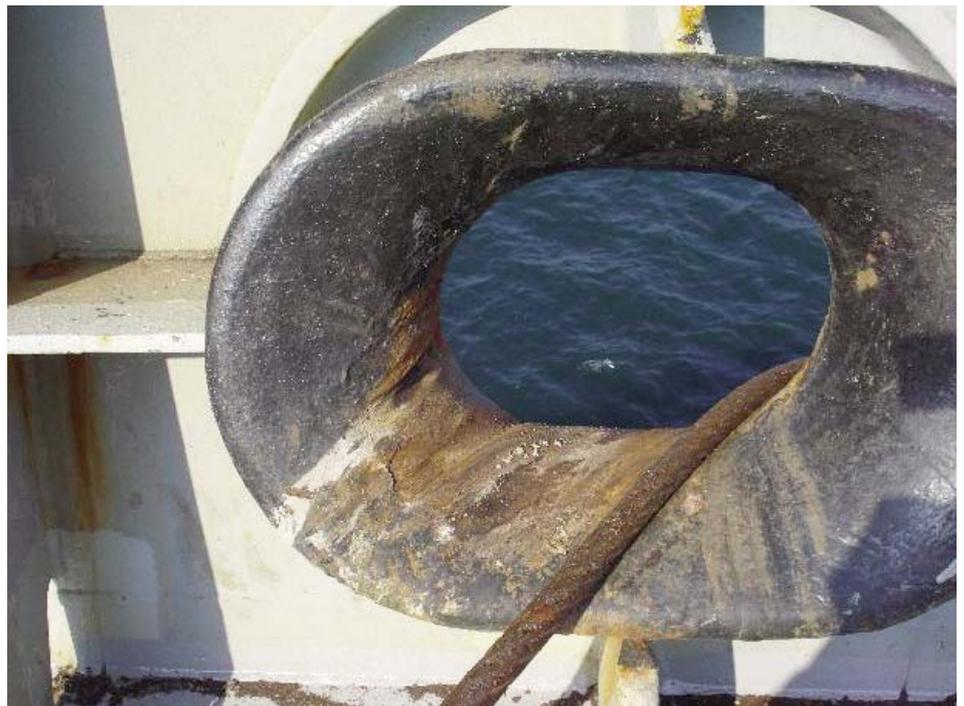
During the operation it was noticed that the Aframaxes closed chocks were not greased, which resulted in the parting of the Suezmaxes two mooring tails, plus a fender pennant line from the Aframax.

The weather conditions and swell resulted in the Aframax experiencing increased rolling when her displacement was reduced during the transfer. Because of the rolling and the freeboard difference, the forces on the mooring lines were increased, thus increasing the friction on the chocks. As a result, the mooring lines parted in way of the chocks.

Closed chock and wire not properly greased.

During the planning phase and prior to the commencement of the STS operation, both Masters should have ensured that the utilised chocks would be sufficiently greased. The use of protective sleeves will contribute to maintaining the mooring lines' sound condition.

Chocks showing scratches and friction marks should be ground and properly greased, as they could damage the mooring lines.

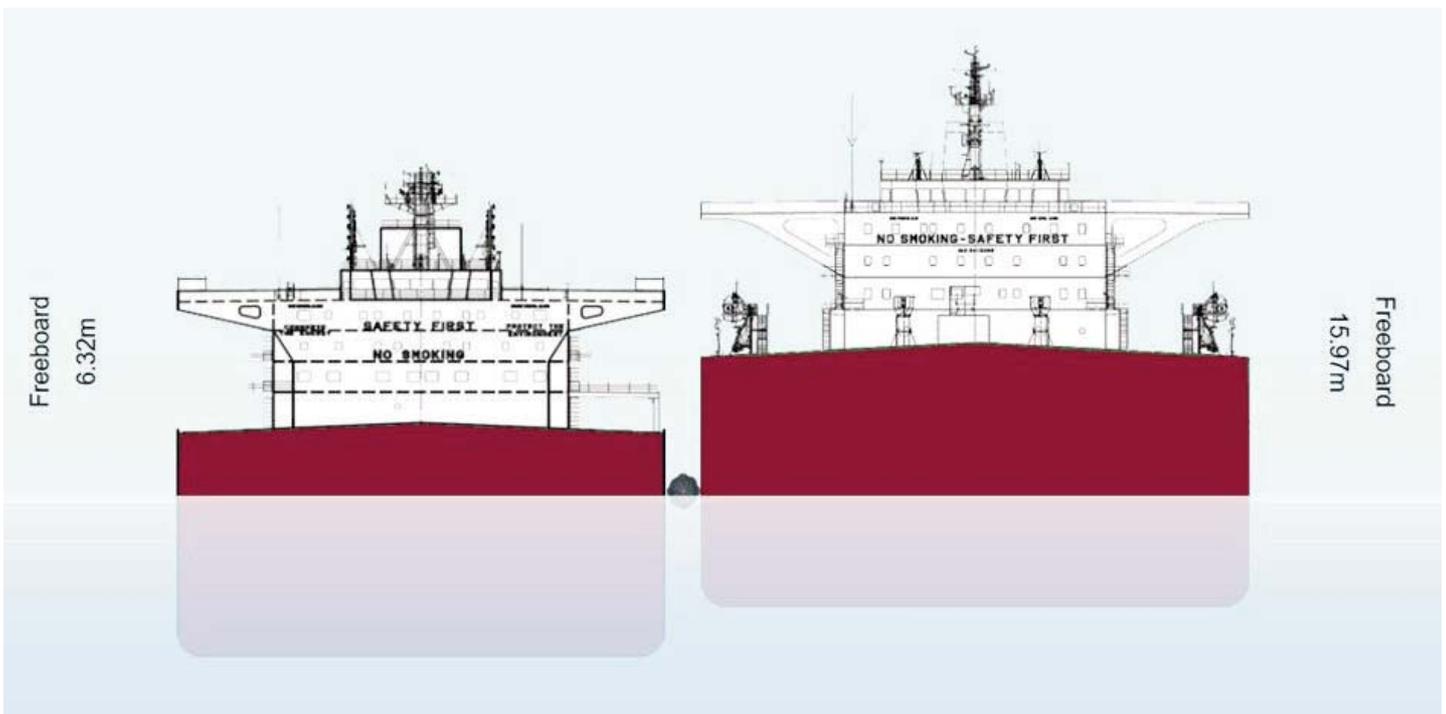
Freeboards before the STS operation.

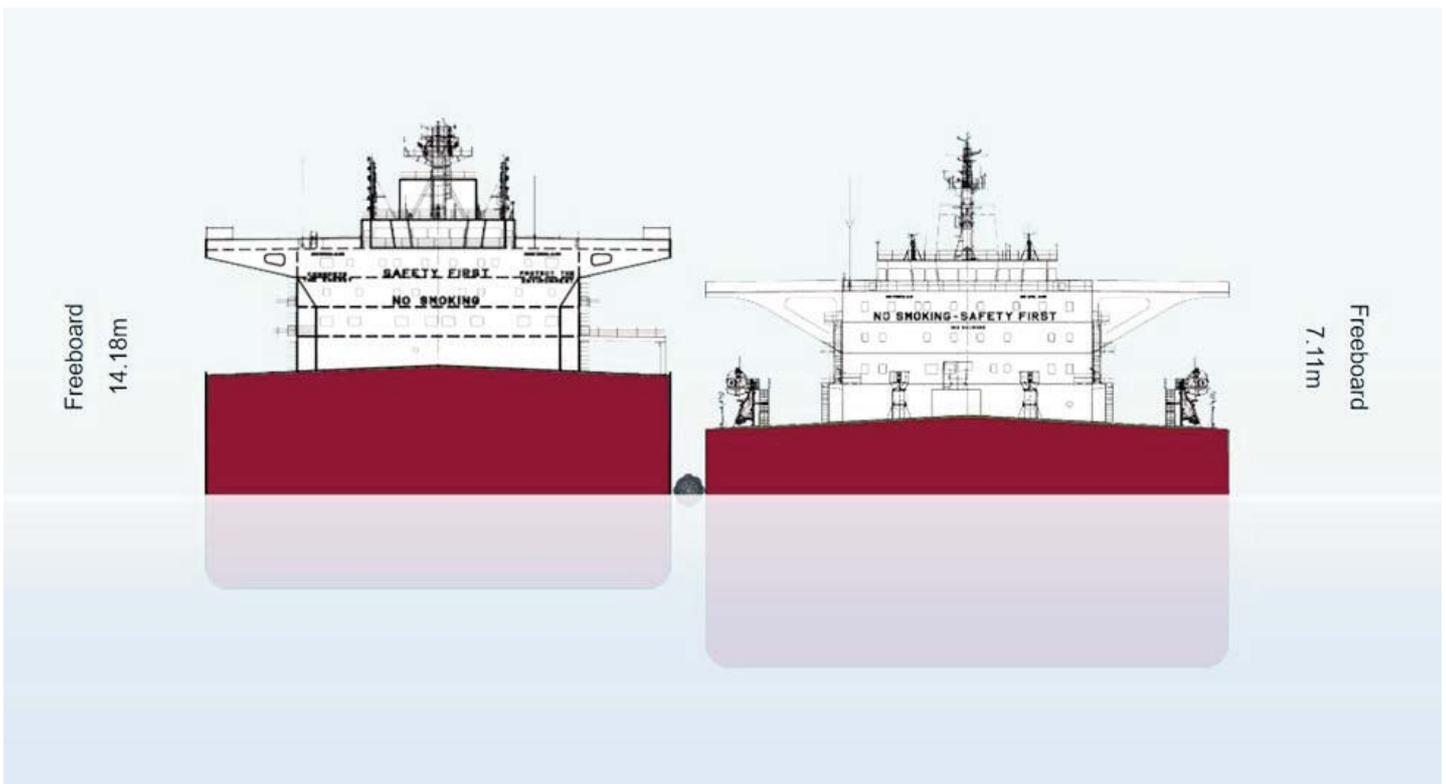
Freeboards after the STS operation.

During the vessel's change of freeboard, the mooring lines, as well as the fender pennant lines, should have been adjusted accordingly to conform to the changed deck heights. The
