CIRCULAR – Due diligence for Service Provider, prior commencement of the STS Operation

THE CASE

DYNAMARINE was recently appointed by a P&I Club in the assessment of a Collision Accident that took place during an STS OPERATION between 2 ships **which are not members of the onlineSTS.net** service.

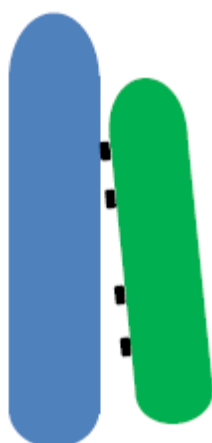
Figure 1

The P&I Club was acting on behalf of the maneuvering vessel that collided during approaching with the constant heading vessel. The STS mooring operation was an underway operation. The collision occurred due to parting of the front pennant rigging line of the forward fender, during the initial contact of vessels (Figure 1). As a result, all 4 fenders dislocated towards the aft parallel body, thus exposing a large side shell area of forward quarter unprotected (figure 2). Further to this event, the maneuvering ship collided on the STBD side of the constant heading vessel.

The primary pennant fender rope broke during the initial contact (Figure 1) ending in dislocation for fenders. No backup pennant fender rope existed. The condition and type of the forward pennant fender rope was not according to manufacturer requirements, thus not as per ISO 17357:2002.

Although secondary fenders were fitted those did not prevent the collision.

1. The service provider should always inform the MASTER of the number and size of the fenders, well prior the commencement of the STS Operation.
2. Fenders size should be in accordance with PART B of the screening and risk assessment report. If the nominated fenders are different from those shown at PART B, DYNAMARINE should be notified (sts@onlinests.net) in case the Master has limited knowledge for evaluation.

3. DYNAMARINE will immediately proceed in amending the fender evaluation section of PART B **to further include** the Manufacturer's **suggested pennant rope** and **chain diameter** with respect to the fender size. In this way the MASTER will have a guideline, for evaluation purposes, when the fenders arrive on-board.

5. Certificates of Fenders and hoses should always be requested prior the initiation of the STS Operation. This is a requirement that should be forwarded from the commercial department, as mentioned above. DYNAMARINE should be notified about the maintenance certificates, either through the Operators or the MASTER. An evaluation of the fenders and hoses should take place as part of due diligence and OCIMF guidelines.
