Date: 08-07-2015

## Multiple mooring lines through ONE closed chock is not a good practice.

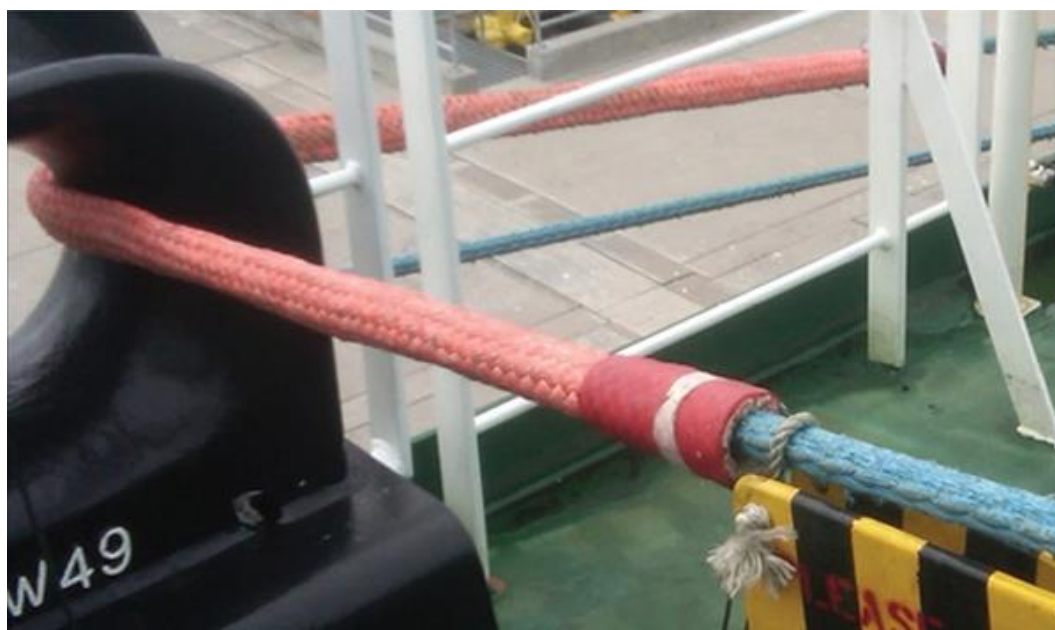
- Mooring lines should be deployed in accordance with the mooring plan. When prevailing weather conditions or weather forecasts require it, additional lines should be deployed. It is recommended that no more than two mooring lines are placed through each chock and secured on a set of bitts. (extract from the latest OCIMF Guidelines)
- In case more than one mooring lines pass through a closed chock, the use of protecting sleeves is recommended, as shown at below picture.
