Date: 13-10-2015

## TO BE DISTRIBUTED TO ALL MANAGED FLEET VESSELS

### THE ROLLING EFFECT AND EXCESSIVE LOADING OF MOORING AND FENDER PENNANT LINES

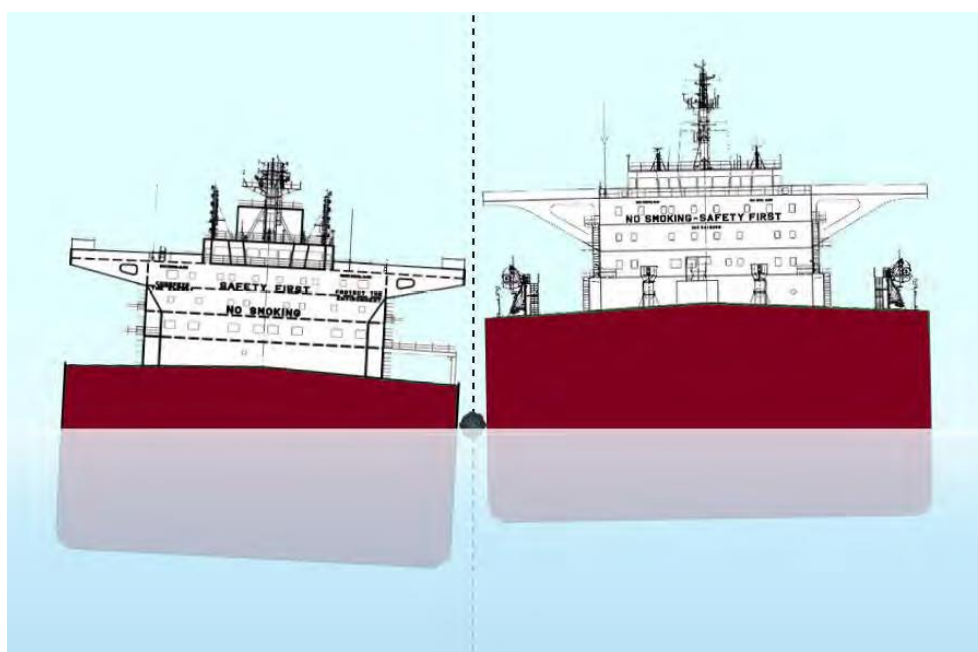
A near miss was recently reported at OSIS from an STS Operation at OFF Southwold. Weather conditions were moderate to rough. The operation was a reverse lightering between an AFRAMAX and SUEZMAX. The AFRAMAX was the manoeuvring and discharging vessel also.

During the operation it was noticed that the closed chocks of the AFRAMAX were not greased thus resulting to parting 2 mooring tails of the SUEZMAX plus a fender pennant line from the AFRAMAX.

Figure 1 : AFRAMAX – SUEZMAX – Reverse Lightering

Weather conditions and swell resulted in increased rolling on the AFRAMAX when her displacement was reduced during the transfer. Because of the rolling and the difference of freeboard, the forces on mooring lines were increased thus increasing the friction on the chocks. Therefore mooring lines parted in way of the chocks.

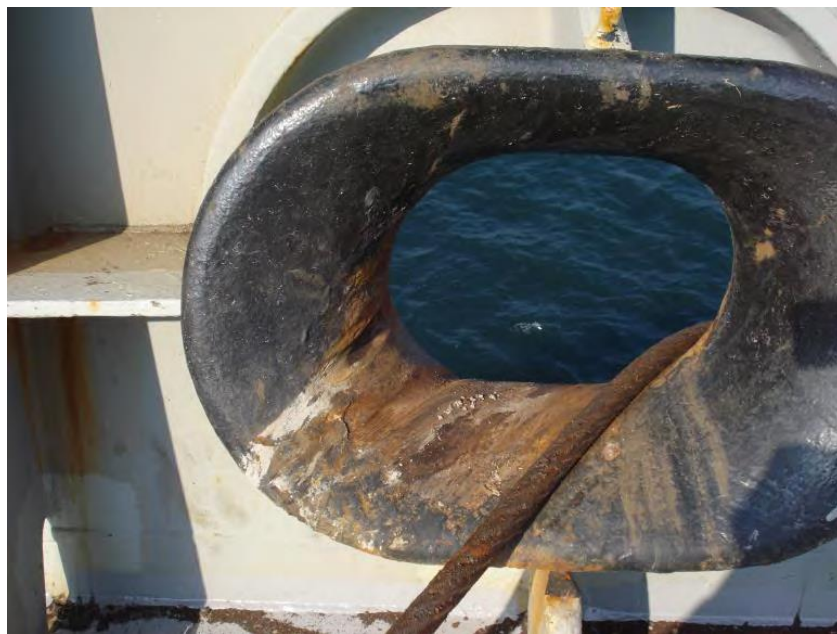
**Figure 2 : Closed chock and wire not properly greased**

Chocks with scratches and existing friction marks should be grinded and properly greased as they could damage mooring lines.

During the planning phase and prior commencement of the STS operation both Masters should ensure that the utilised chocks will be sufficiently greased. The use of protective sleeves will contribute in maintaining sound condition of mooring lines.

Masters and POAC should ensure that a confirmation on proper preparation of chocks should exist during agreement of the JOINT PLAN.

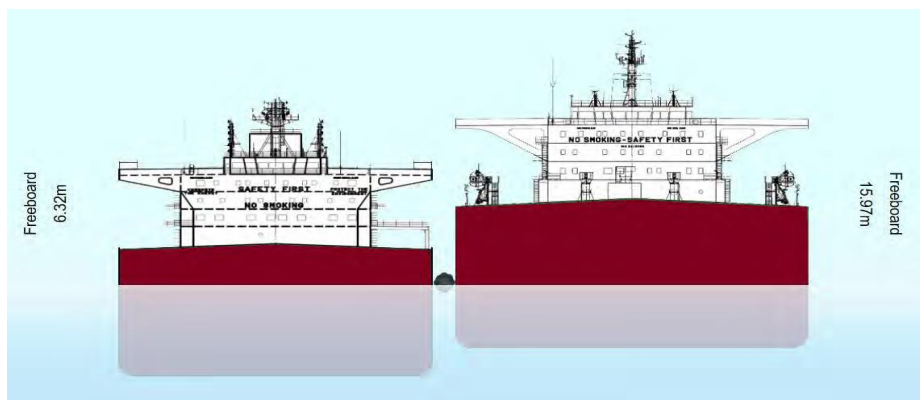
**Figure 3 : Freeboards before the STS operation**

During change of vessel freeboard, mooring lines as well as fender pennant lines should be accordingly adjusted to conform to corrected heights. The POAC should actively monitor such changes and advise both Masters to take action promptly.

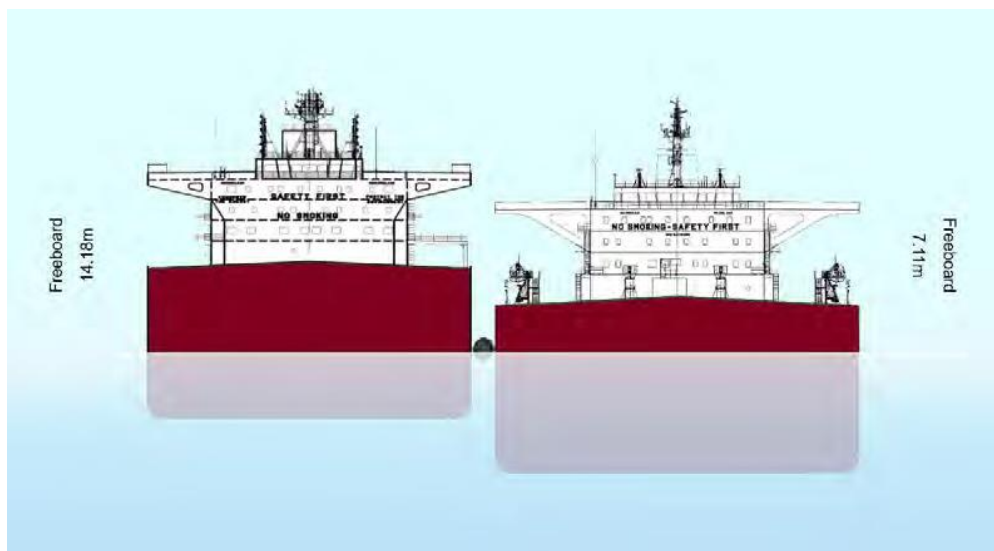
The involved POAC, although altered vessel direction towards the swell, in order to reduce vessel rolling, did not promptly advise Masters in order to avoid the breaking of lines. The fender pennant lines should have been adjusted, relevant to freeboard increase of the discharging (and manoeuvring) vessel.

**Figure 4 : Freeboards after the STS operation**
