Beware the rolling effect

A near miss was recently reported on DYNAMARINE's OSIS online STS.net service regarding a ship-to-ship (STS) cargo transfer operation off Southwold on the UK's East Coast.

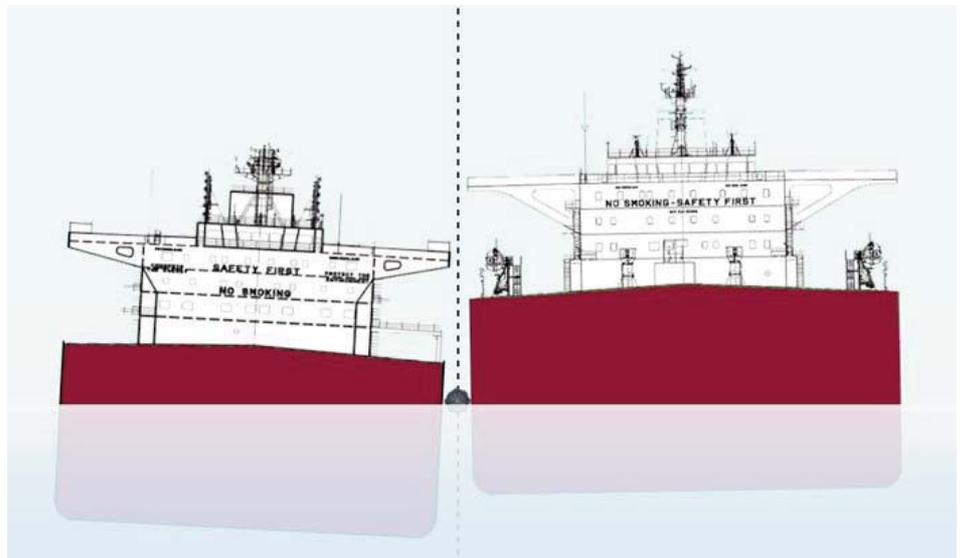
During the operation it was noticed that the Aframaxes closed chocks were not greased, which resulted in the parting of the Suezmaxes two mooring tails, plus a fender pennant line from the Aframax.

The weather conditions and swell resulted in the Aframax experiencing increased rolling when her displacement was reduced during the transfer. Because of the rolling and the freeboard difference, the forces on the mooring lines were increased, thus increasing the friction on the chocks. As a result, the mooring lines parted in way of the chocks.

The Aframax left and the Suezmax right undergoing reverse lightering. Source: DYNAMARINE.

During the planning phase and prior to the commencement of the STS operation, both Masters should have ensured that the utilised chocks would be sufficiently greased. The use of protective sleeves will contribute to maintaining the mooring lines' sound condition.

Chocks showing scratches and friction marks should be ground and properly greased, as they could damage the mooring lines.
